Altec Lansing BoomJacket Bluetooth Board Replacement

This replacement guide for the Altec Lansing BoomJacket will give step by step information about how to repair the Bluetooth Board in your device.

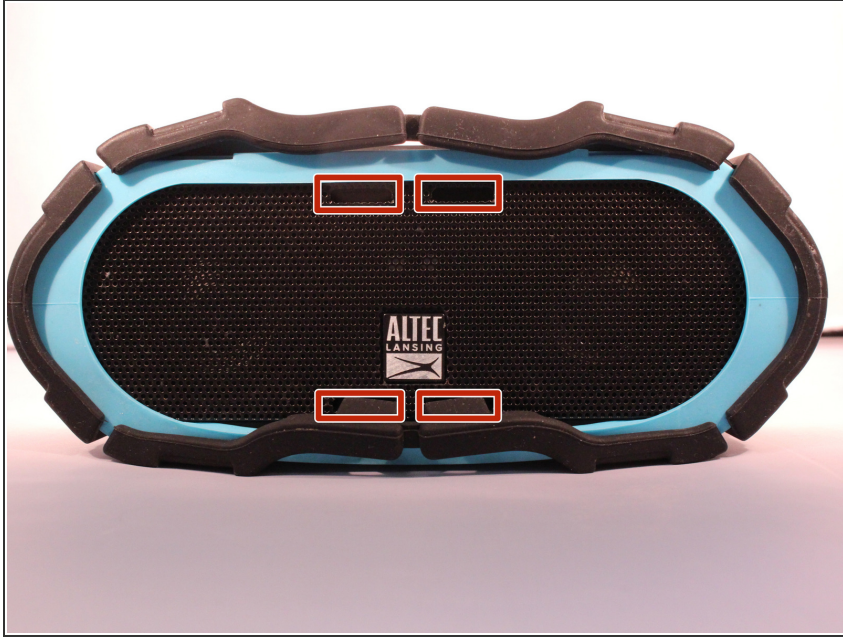
Step 1 — Case Removal

- Using your hands, remove the pegs (4+4) from the front and back of the speaker.

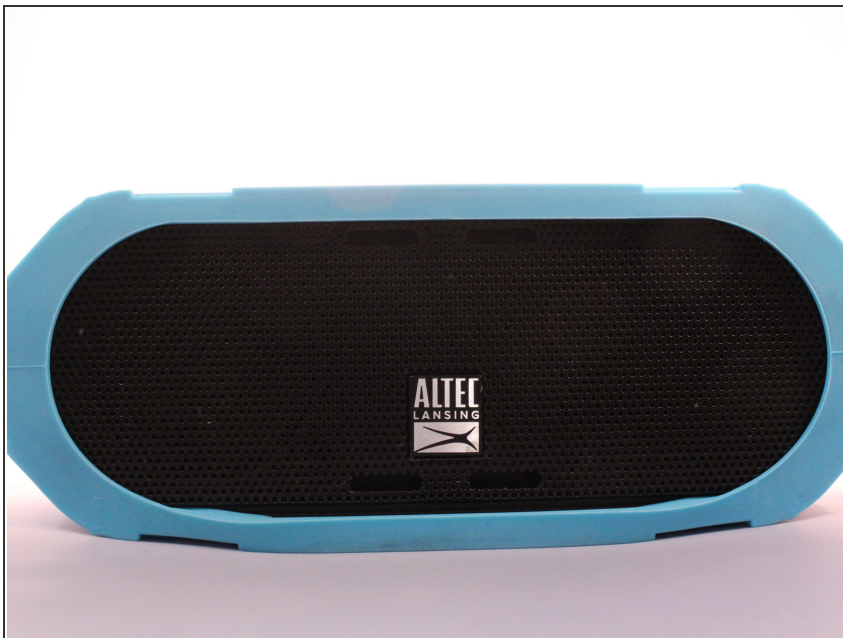
Step 2

- Remove the outer black rubber housing of the speaker.

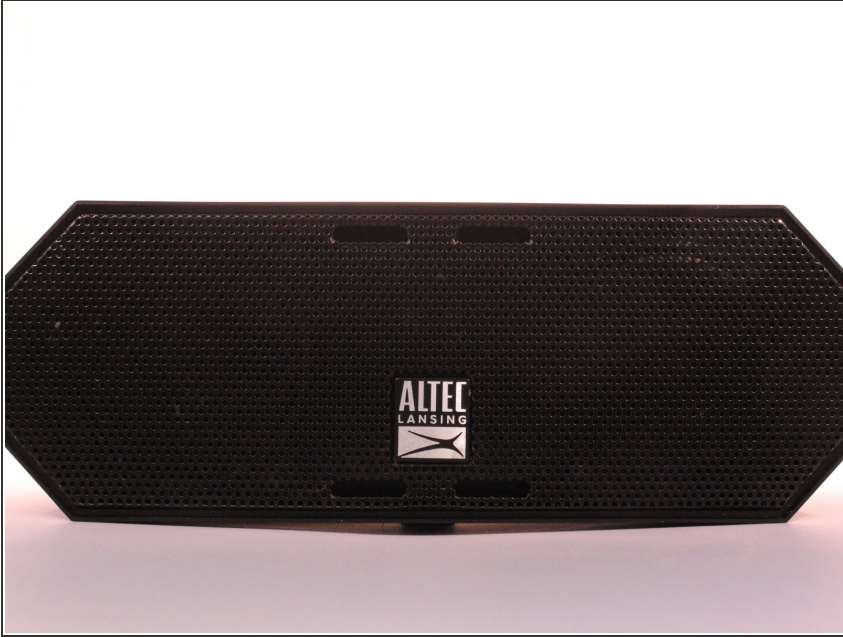
Step 3

- Remove the inner blue rubber housing from the speaker.

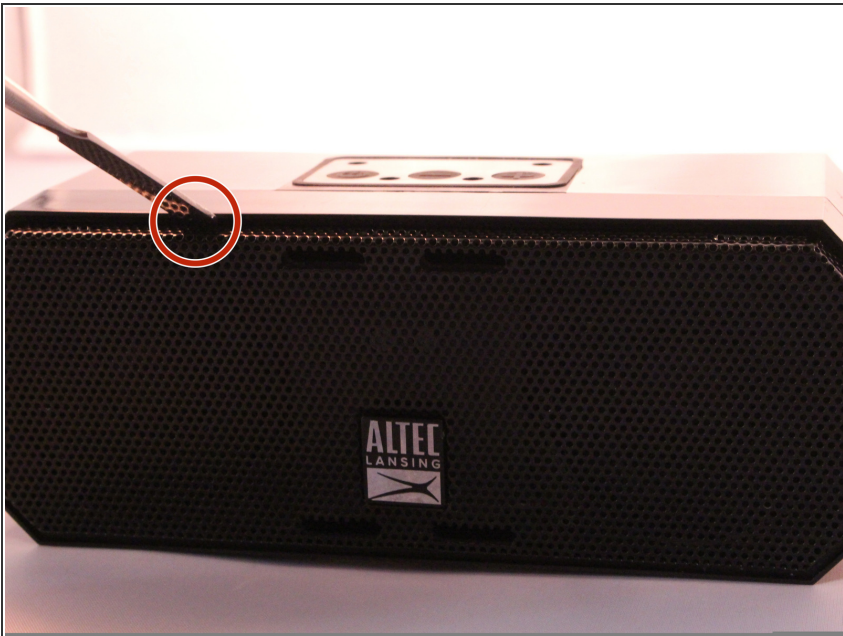
Step 4

- Pull out the two black wire meshes using a metal spudger.
- ⚠ Be careful not to damage the metal casing.

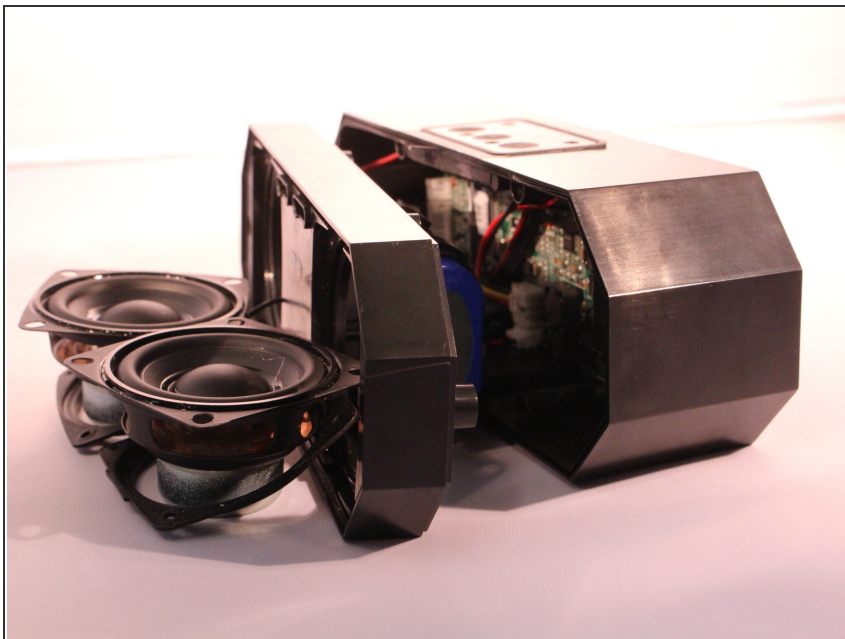
Step 7

- Pull the case apart and you will be able to see all the components inside the speaker.
